Report on April 2024 Visual Inspection

In accordance with the additional service requested under Project HB100013 for Hobsonville Seaplane Ramp, we carried out a visual inspection on Friday the 5th April 2024 at which time we also measured beam deflection at a previously installed fixed observation point and observed crack widths at previously installed crack gauges and did manual crack width measurements of some of the worst affected beams near the outer edge of the structure. The inspection was carried out by s 9(2)(a) who also did the last inspection and load test monitoring in 2023.

Site Visit Report N° 1

Project: Seaplane Ramp Asset Management
Principal: Kainga Ora
Contractor: not applicable

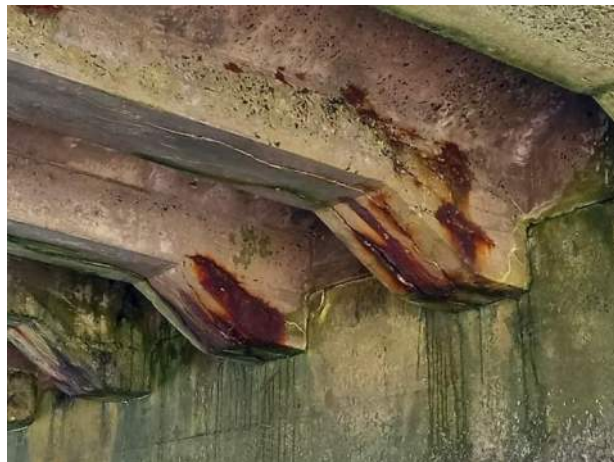
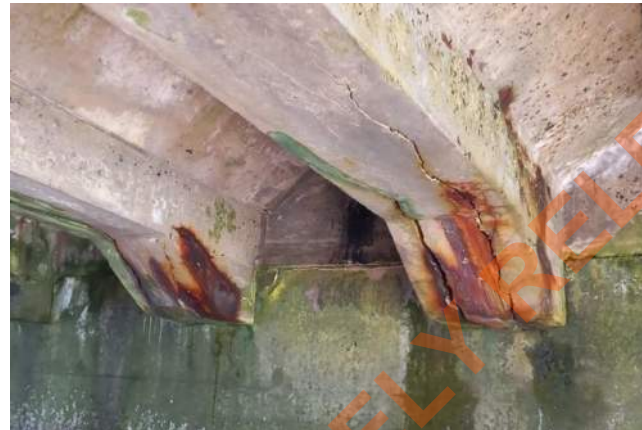
Longitudinal Deck Slab Girders (Span 2 at Gridline C end)

10mm- 20mm significant Longitudinal concrete cracks along existing P.C beams with severe induced corrosion of reinforcement bars.

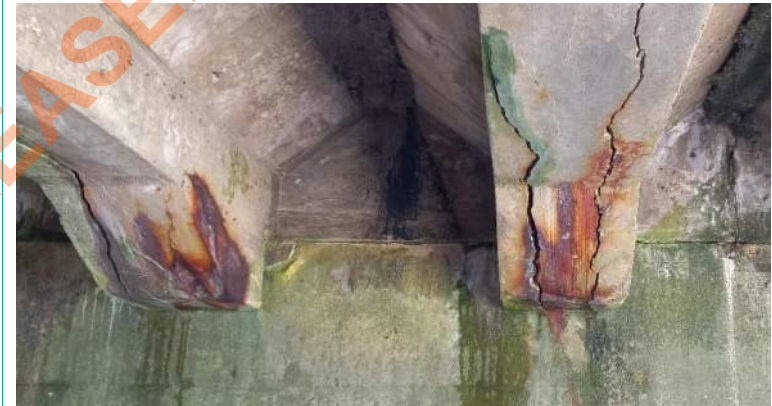
However, of minor concern are observations that some spalls and cracks on the deck upper surface have visibly deteriorated and of greater concern is an observation that some of the widest longitudinal cracks on the underside of beams have significantly widened, and that some concrete is poorly attached.

15mm- 23mm significant Longitudinal concrete cracks along existing P.C beams with severe induced corrosion of reinforcement bars.

It should be noted that as loss of reinforcing continues, the reliability of infrequent load test as proof of safety will decrease, because structural performance will become increasingly erratic as reinforcing loss approaches some critical level. Since no beams have been tested to failure, we do not know how close previous test load demands were to the current capacity of the beams, so do not know if eventual failure from ongoing loss of reinforcing is imminent or likely after many more years. Therefore, despite the successful load tests that were conducted in February 2023, and the latest observation that there has been relatively little overall change in the condition since then, we consider the widening of some cracks to be sufficient evidence for us to be unable to advise Kainga Ora that it remains safe to keep the ramp in limited use for another year. Therefore, we recommend that the ramp is removed from service in the near future.

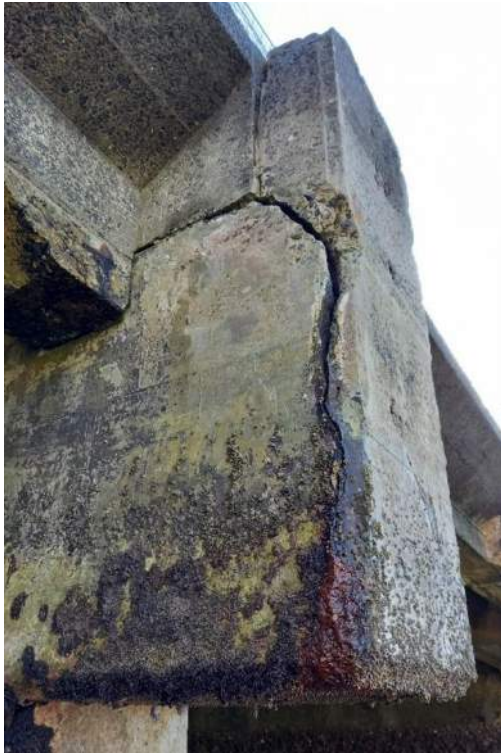
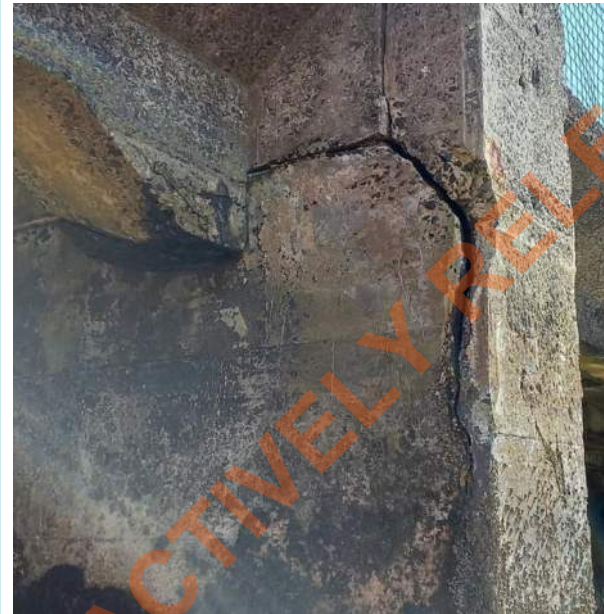
Pier Capping Beam at Gridline C

Severe concrete cracking of the capping beam upstand at the eastern end, approx 20mm wide.

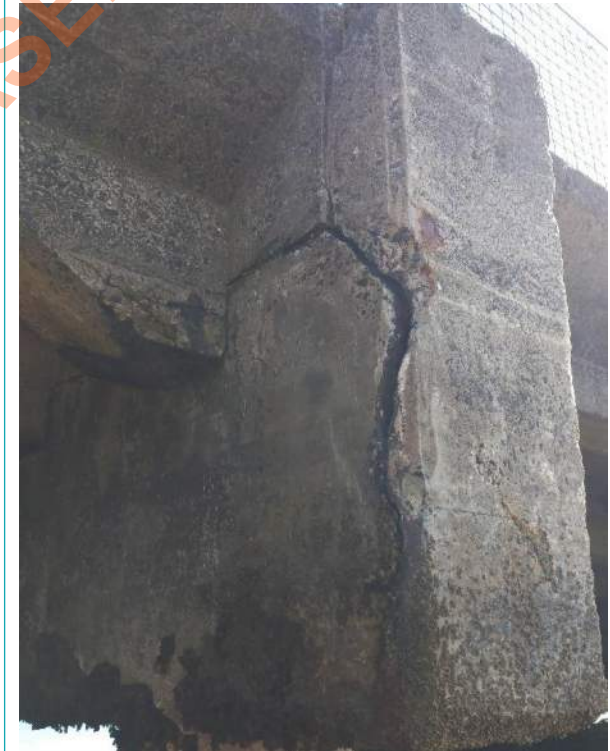
Severe concrete cracking of the capping beam upstand at the eastern end, approx 23mm wide.

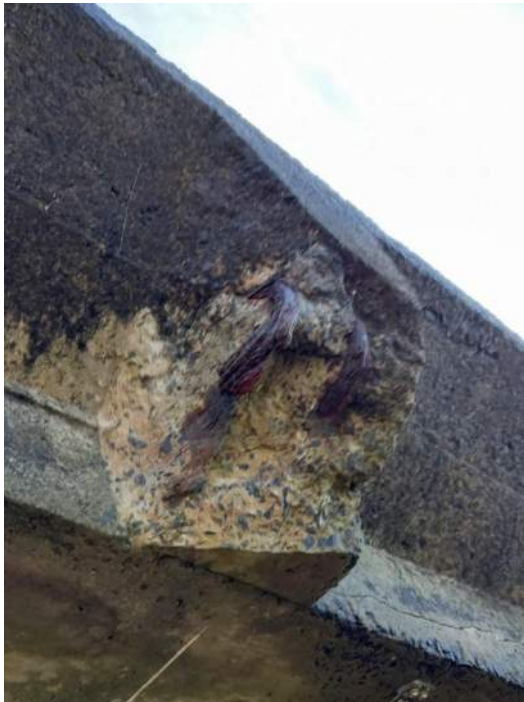
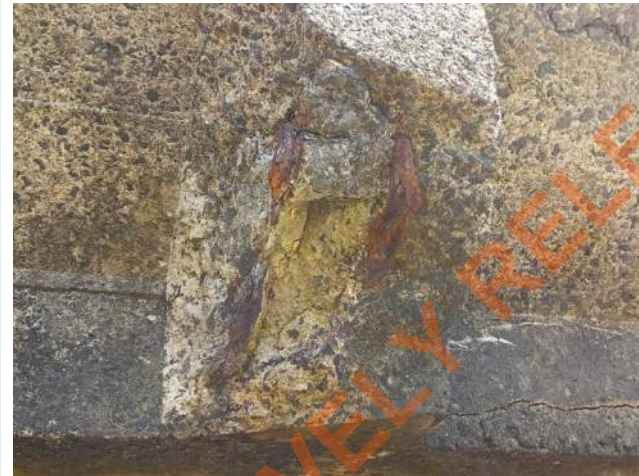
Transverse beam span 3 overhang Beam Units (Span 3)

Spalling of concrete with Existing transverse bottom reinforcement lost due to severe corrosion.

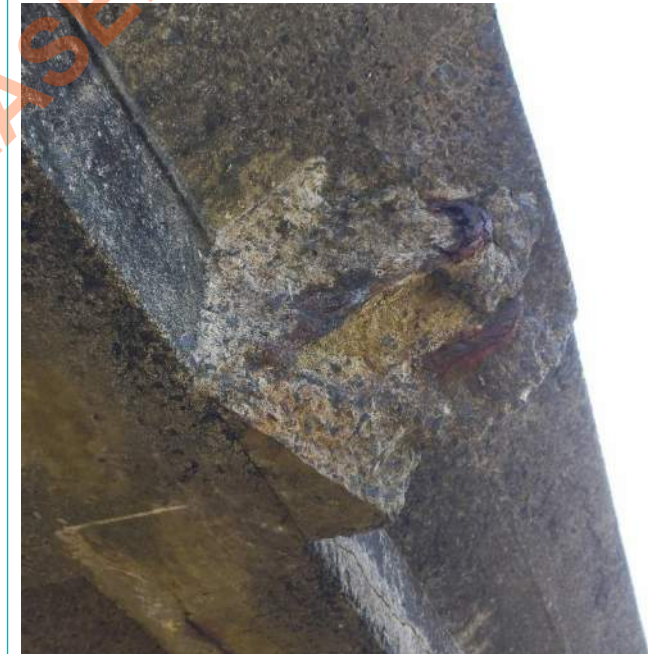
Existing transverse bottom reinforcement lost due to severe corrosion

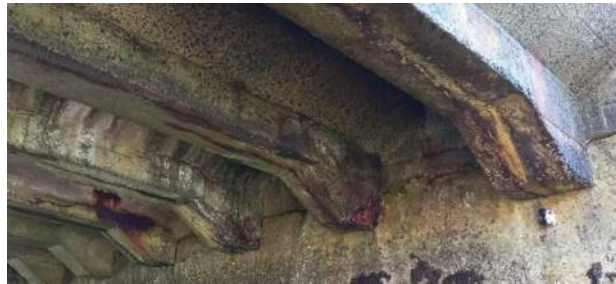
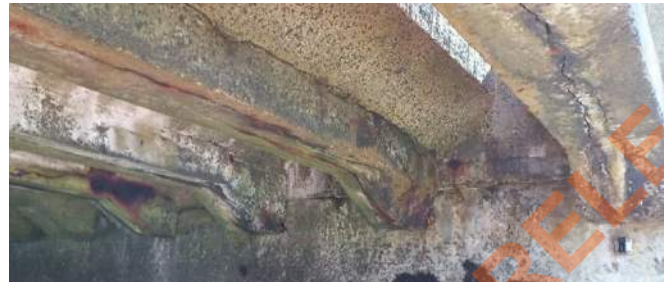
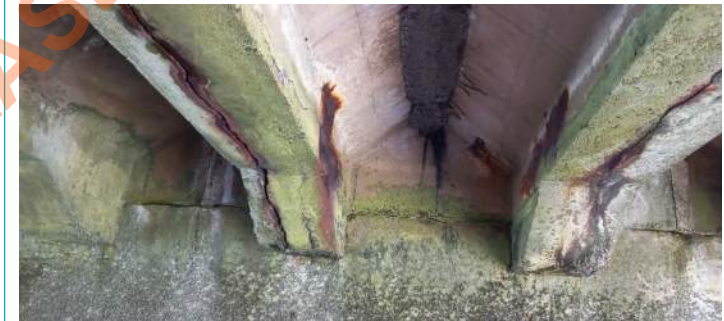
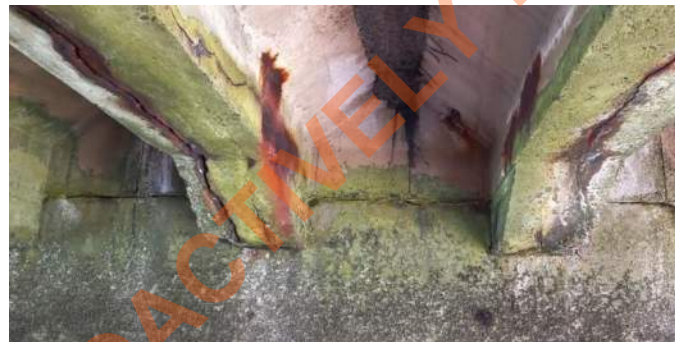
Longitudinal Beam Units (Span 3), towards eastern side

10mm- 20mm significant Longitudinal concrete cracks along existing P.C beams with severe induced corrosion of reinforcement bars.

15mm- 22mm significant Longitudinal concrete cracks along existing P.C beams with severe induced corrosion of reinforcement bars.

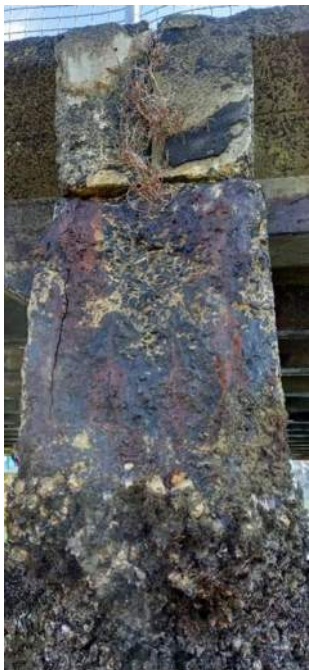
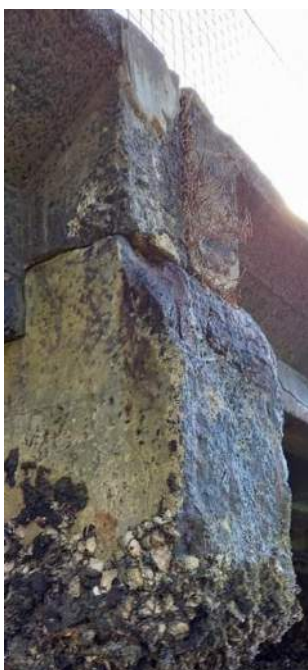
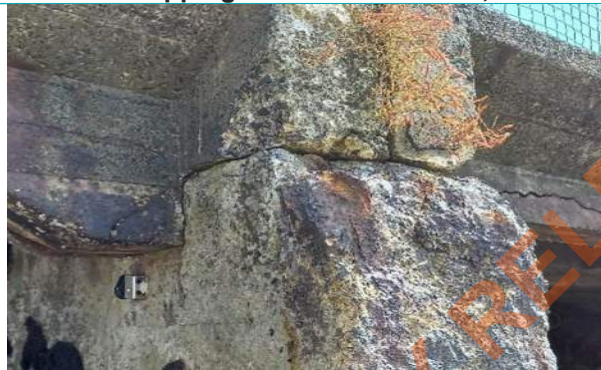
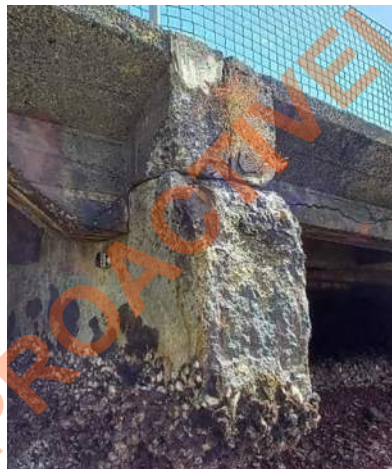
Pier Capping Beam at Gridline D, Eastern Side

Capping beam eastern end upstand wall lost due to severe concrete spall and reinforcement corrosion.

There is also an increasing risk of concrete falling off the underside of the structure and pile cap ends, and we recommend that beach level access to the ramp is prevented.

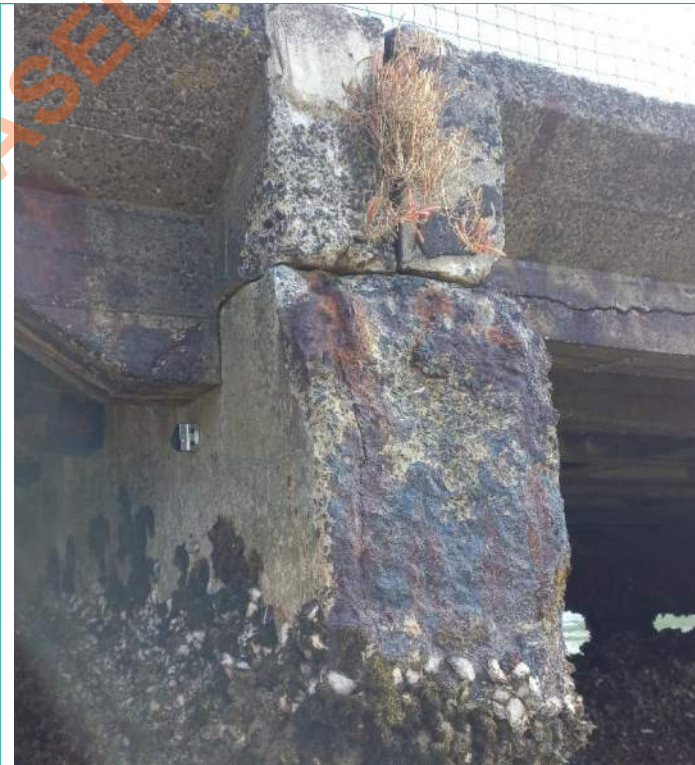
Capping beam eastern end upstand wall, severe corrosion induced cracking of concrete.

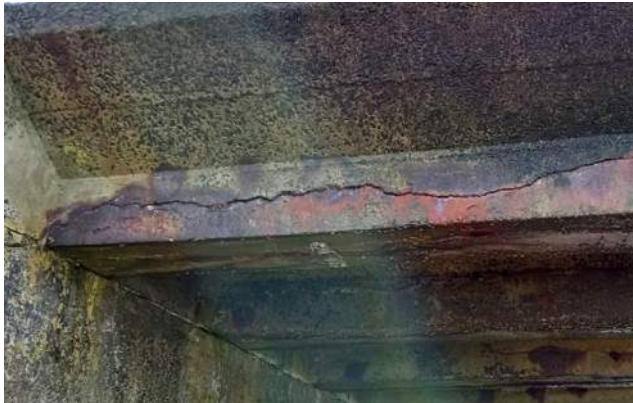
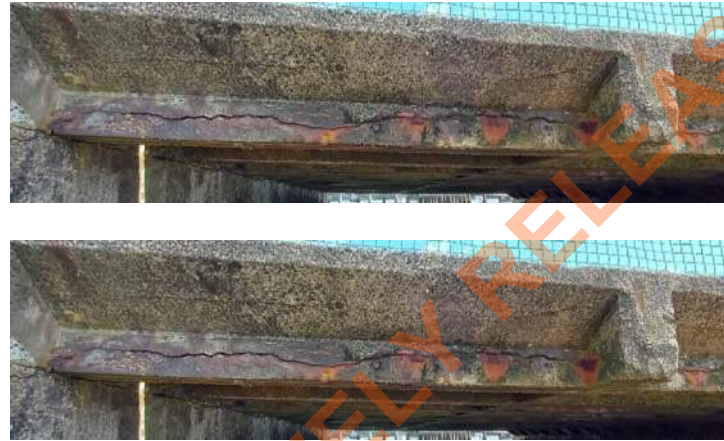
Longitudinal Beam Units (Span 4)

10mm- 20mm significant Longitudinal concrete cracks along existing P.C beams with severe induced corrosion of reinforcement bars.

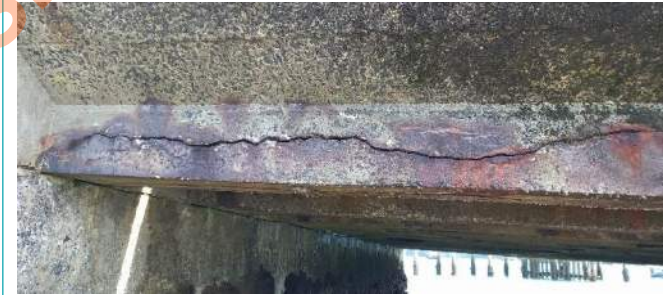
15mm- 22mm significant Longitudinal concrete cracks along existing P.C beams with severe induced corrosion of reinforcement bars.

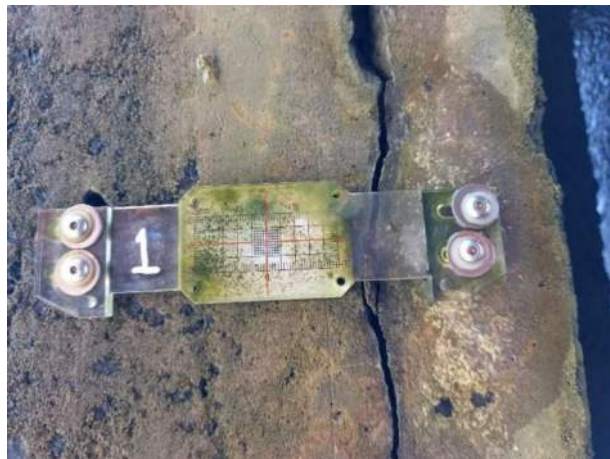
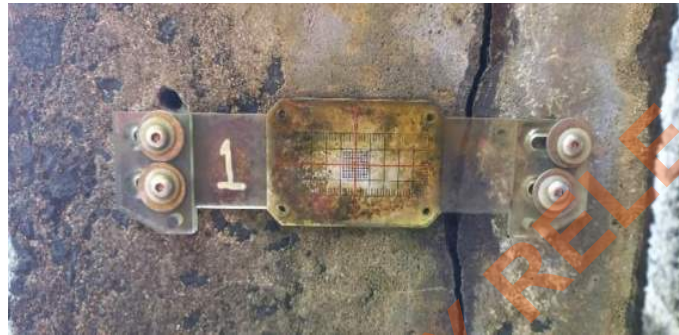
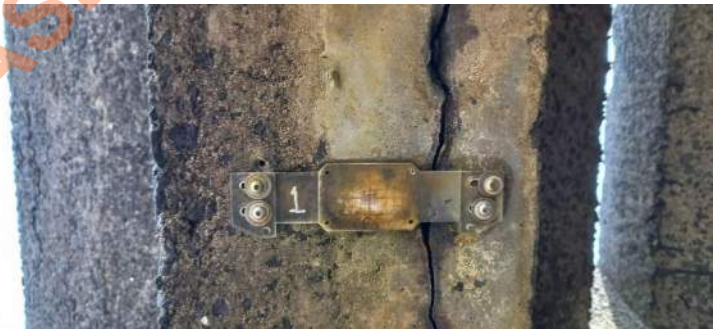
Crack Gauge 1: Soffit of Span 3 Edge Girder at Midspan

Some evidence obtained from this inspection is positive but other evidence is worrying. I will cover the positive evidence first. None of the crack gauges installed across significant cracks in November 2019 have moved since they were installed, and the vertical distance measured between the underside of span 3 eastern outer beam and a tight reference line has also not significantly changed since 2021. The vertical measurement aims to detect vertical movement of the beam at mid-span, where progressive sagging over several readings would indicate loss of flexural capacity and random fluctuation would indicate normal changes in thermal gradient. The latest measurement in one location is 2mm smaller than in 2023 and is the same as in 2021 and in another location is stable, so there is no indication of loss of flexural capacity.

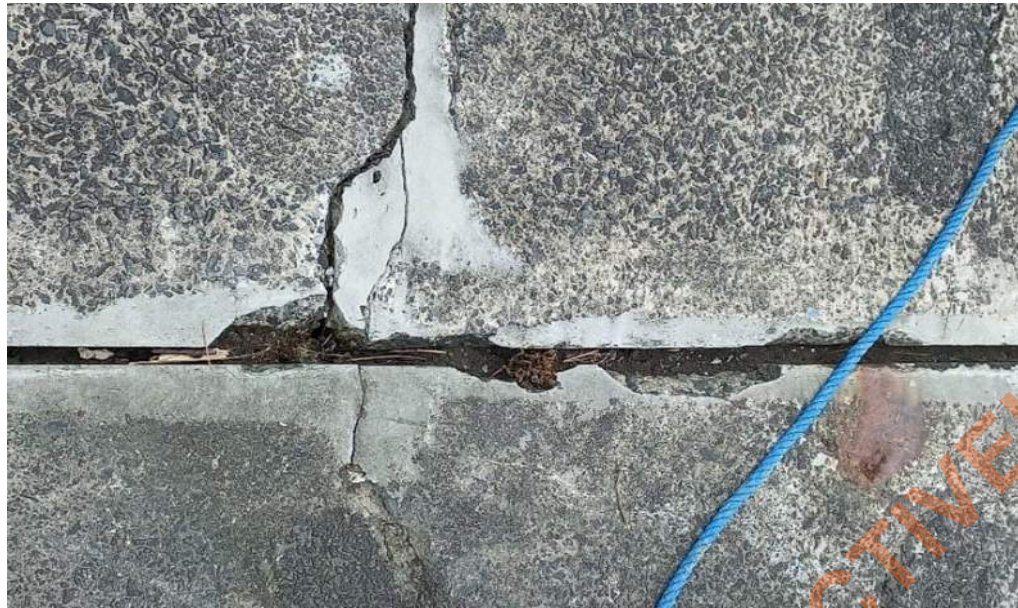
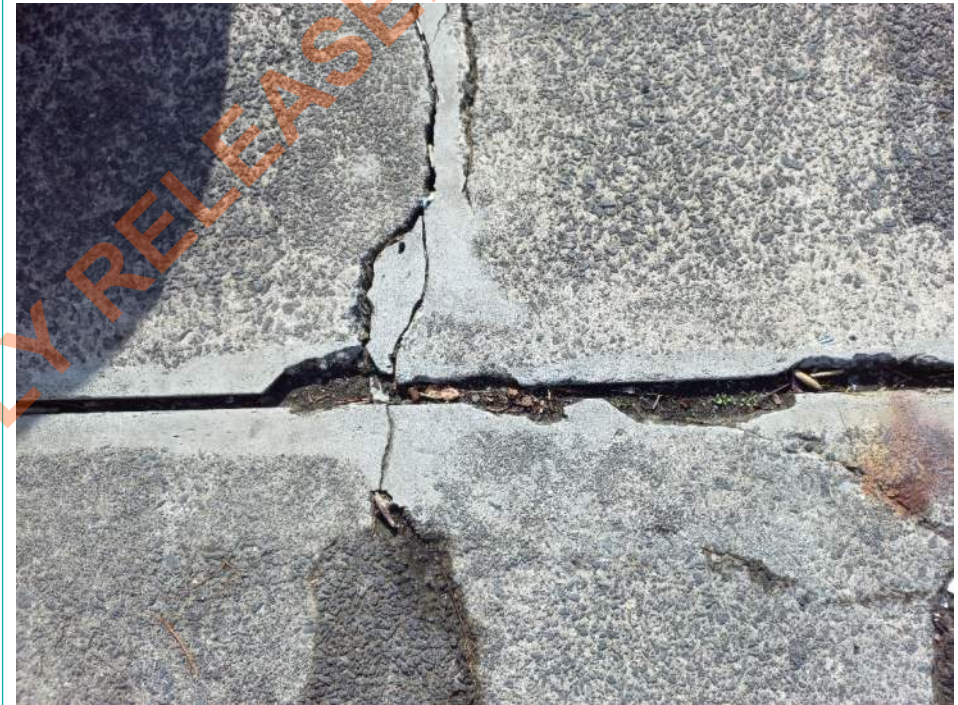
Top surface – Cracking & spalling at joints above piers (Pier at Gridline E)

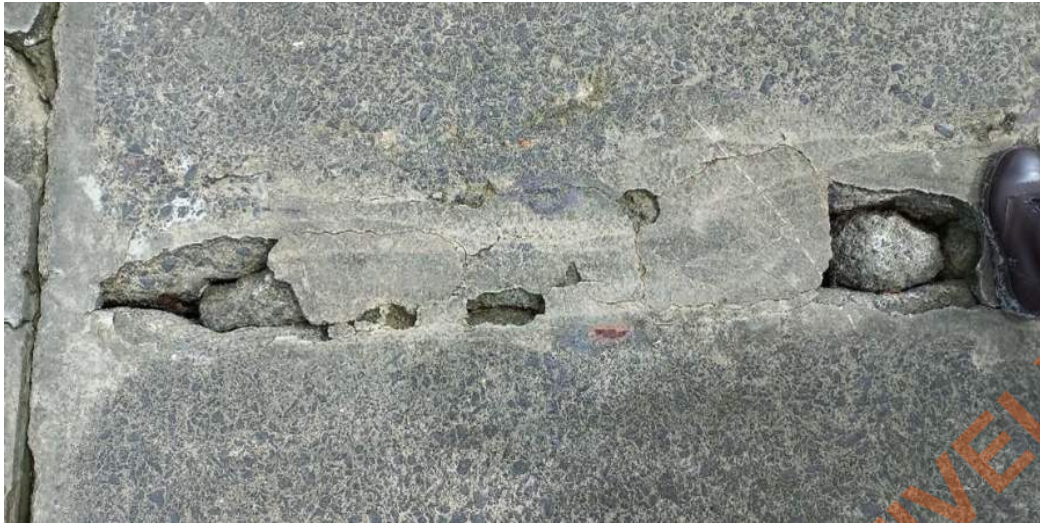
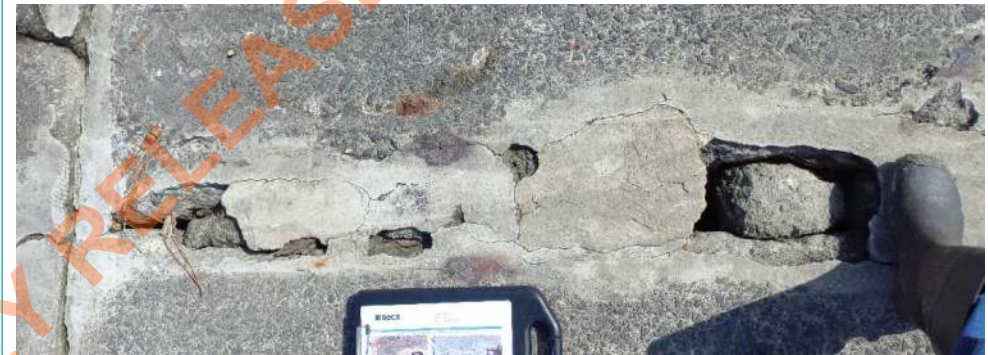
Top surface – Cracking & spalling of grout between longitudinal girders (Span 6 – Grid F).

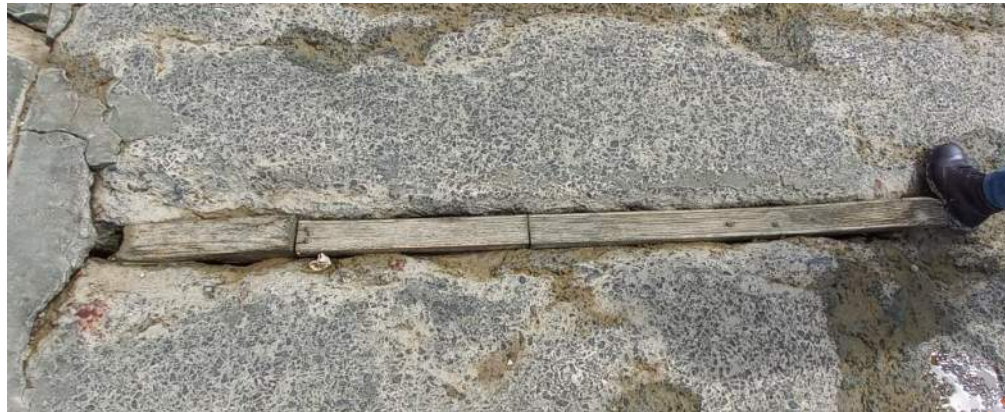
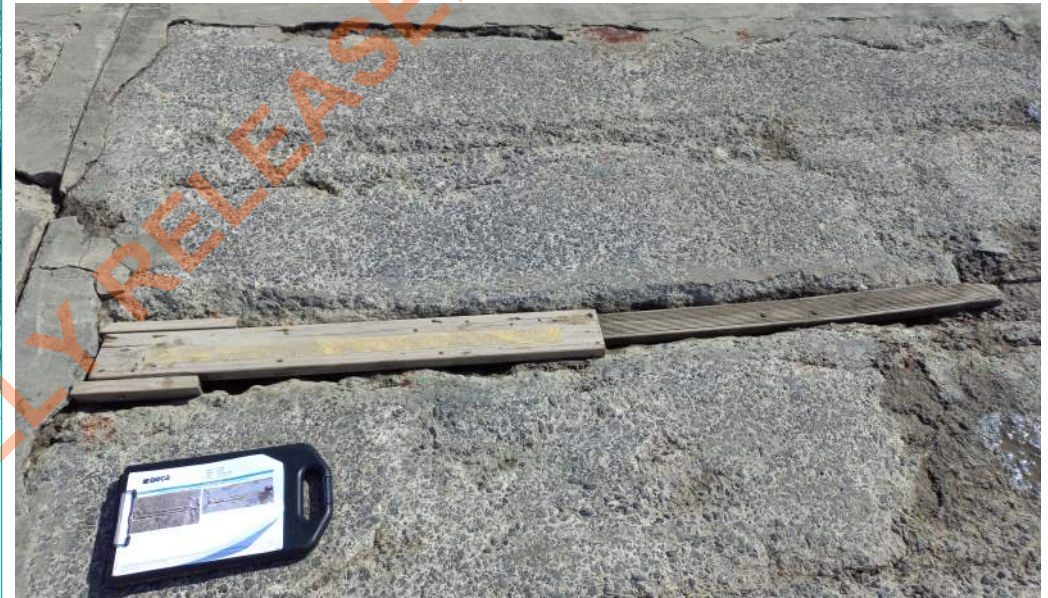
Top surface –Spalling of grout in span 7 (Grid G) with timber planks wedged into place to fill the void.

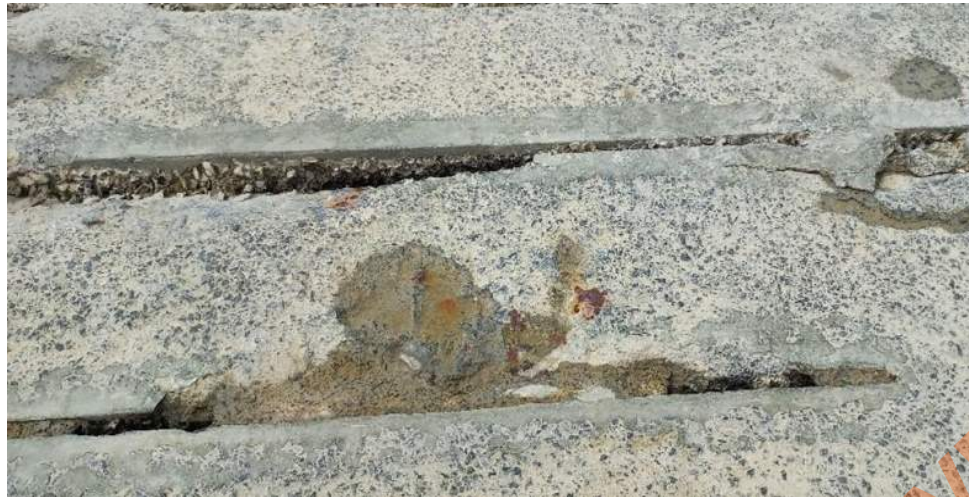
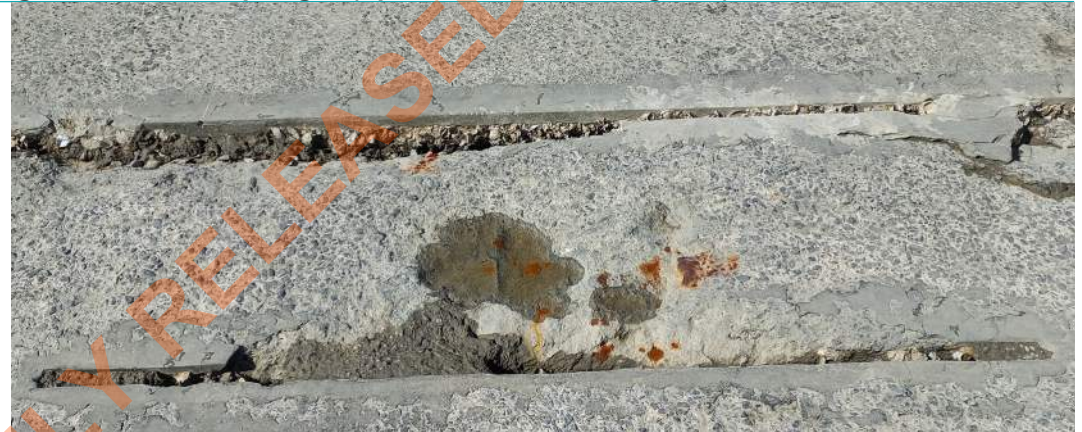
Top surface - Spalling of grout between the first two girders at the ramp edges (Span 7 -Eastern Outer girder).

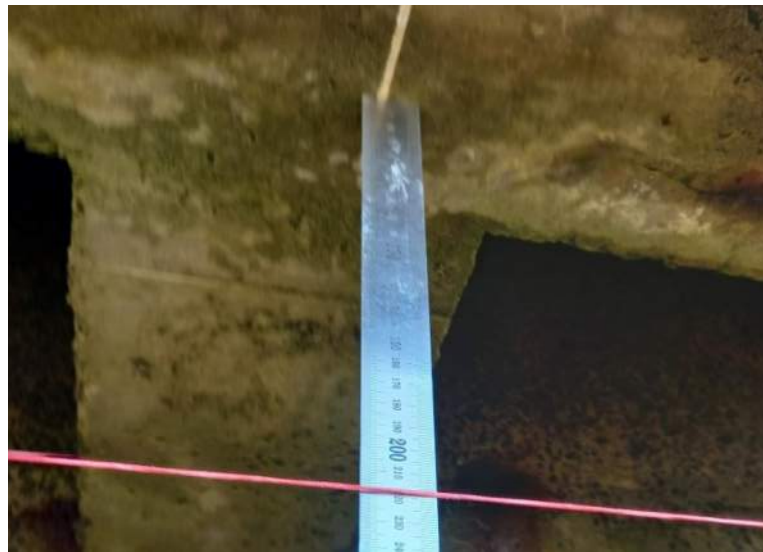
Beam deflection check Span 3 Eastern Outer girder.

2021 inspection reading at the southeast outer girder = 218mm

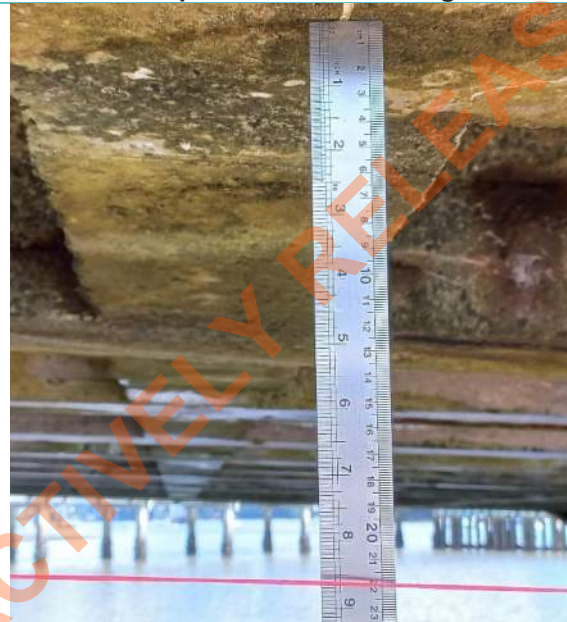
2023 inspection reading at the southeast outer girder = 220mm

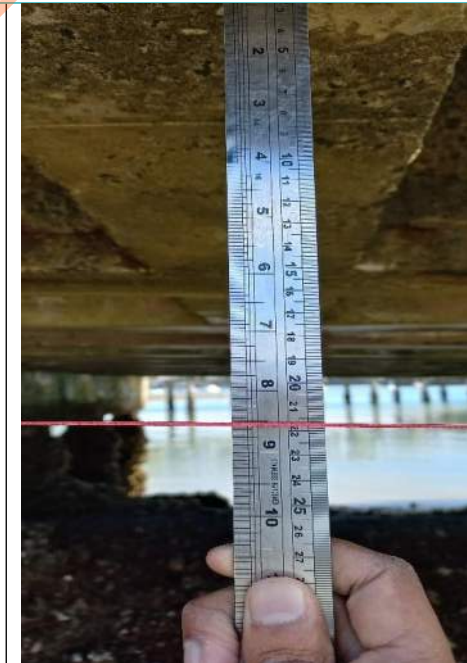
2024 inspection reading at the southeast outer girder = 218mm

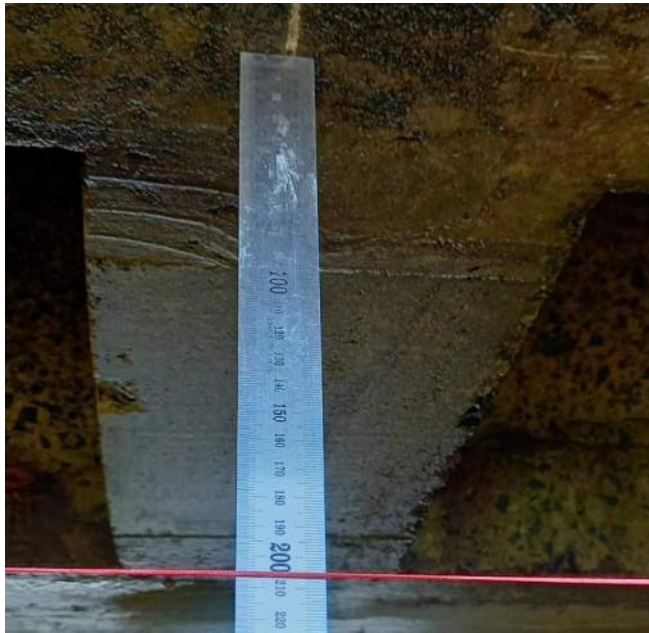
Beam deflection check Span 3 Eastern Outer girder.

2021 inspection reading at the northeast outer girder = 205mm

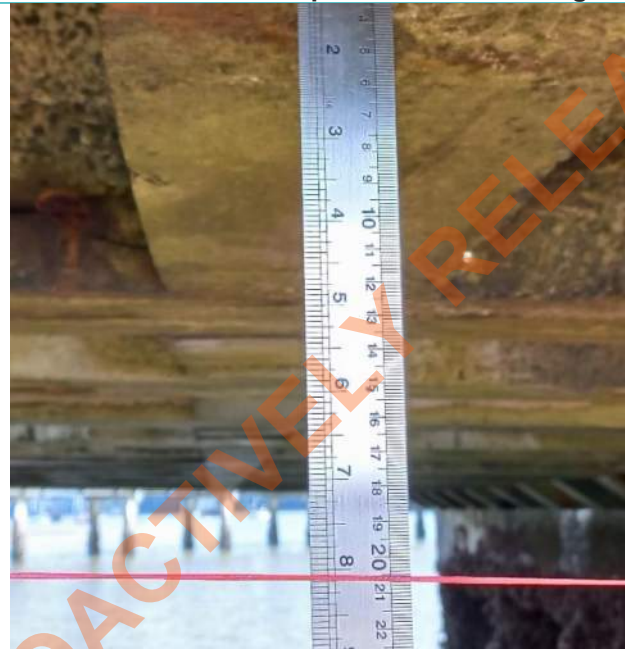
2023 inspection reading at the northeast outer girder = 205mm

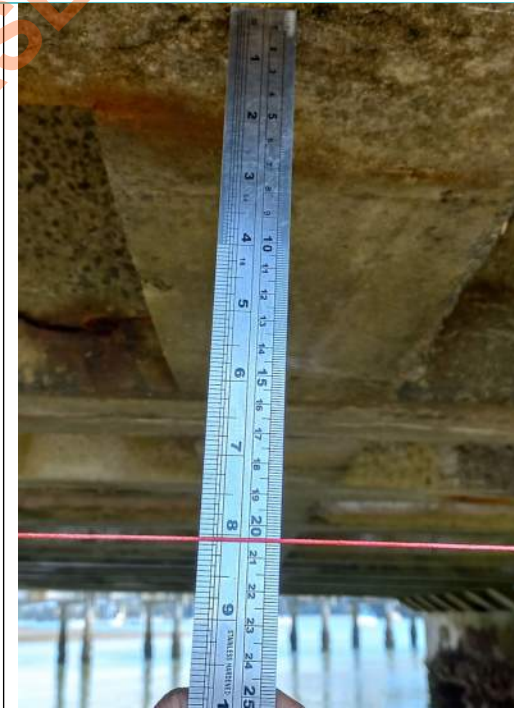
2024 inspection reading at the northeast outer girder = 205mm
